The Bolted Timber Connections: Bearing Shear Failure with the European Yield Model (EYM)

Abstract: This research is about the bolted connection strength of Belian hardwood that failed in bearing shear. This research focuses on unreinforced masonry buildings (URM) which are located around Kuching town area. The history of unreinforced masonry (URM) buildings in Sarawak started with the building of Fort James in 1849 in Kapit and was followed by Fort Emma in 1851 in Kanowit whereby the first URM building in Kuching itself was the Government House which was built in 1857 by first Rajah of Sarawak. Until today, the URM buildings in Kuching still exist and play an important role as commercial buildings such as banks, restaurants, boutique hotels, lodges, and even post offices. For example, the General Post Office building at Jalan Tun Abang Haji Openg, is still being used and maintained as a fully: functional post office. As observed in recent disasters, it is established that URM buildings are vulnerable to earthquakes. There are some causes that may lead to the collapse and failure of URM in seismic movements. Even though the URM buildings in Malaysia are designed according to the Ma

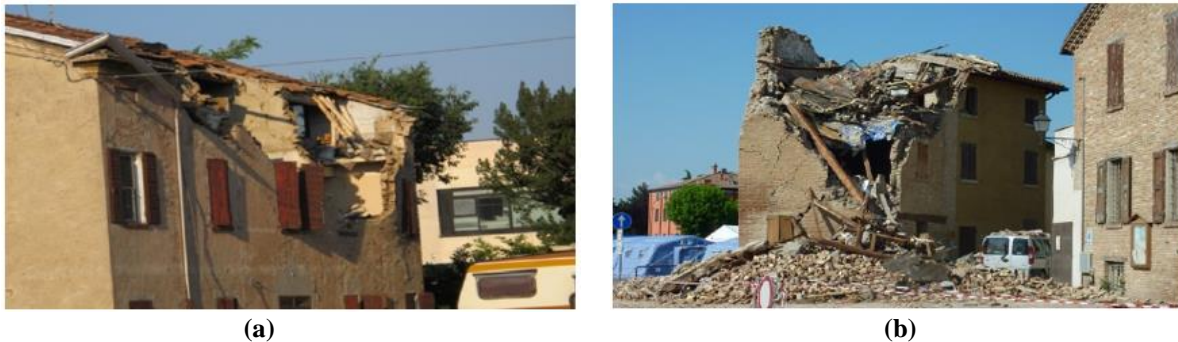
Fig. 1: (a) 2012 Emilia earthquake: collapse due to the absence of connections between floor/diaphragm and masonry walls; (b) collapsed due to the absence of efficient floor and roof diaphragms

As observed in recent disasters, it is established that URM buildings are vulnerable to earthquakes. There are some causes that may lead to the collapse and failure of URM in seismic movements. One of the main causes of overturning and collapsing walls during an earthquake is a poor connection between the structural members in masonry walls and the wood diaphragm (Abdul Wahap, 2016). This phenomenon was proven when the Emilia earthquake struck in 2012, where

URM buildings collapsed as the floor/roof diaphragm was not efficiently connected with masonry walls (Ongaretto et al., 2016) as show in Fig. 1 (a) and (b).

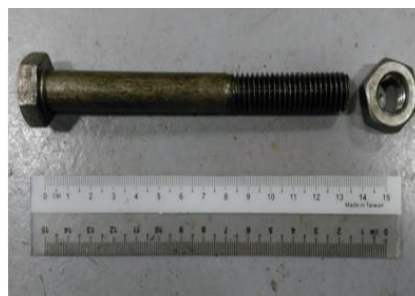
Fig. 3: Grade class of 4.6 bolt and nut

In Sarawak, Belian hardwood is typically used to construct the floor and wall diaphragm for URM buildings in the Kuching area. The Belian used in this study was local hardwood, purchased from a factory of Min Liong Sdn. Bhd, Kota Samarahan. The experiment was conducted to determine the moisture content and density, embedding strength test and bolted connection strength test. The selection of bolt and nut is based on the ASTM F 568 grade class of 4.6, as shown in Fig. 3, where the material that was used is from medium carbon alloy steel with a minimum tensile strength of 400MPa and 240MPa yield strength. The 13mm diameter bolt with 135mm length meets the configuration of the testing.

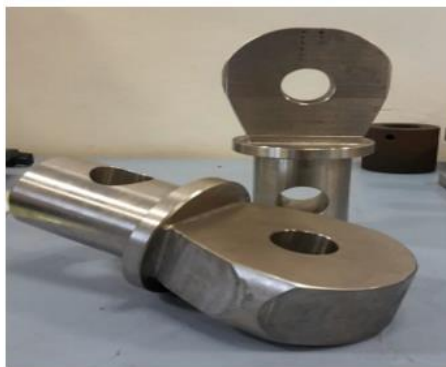
Fig. 4 (a) Stainless steel rig fabricated; (b) Stainless steel rods and mild steel plates
